**CONSTRUCTION INSPECTION AND
DEMONSTRATION PROJECT
FOR
SEDIMENT MONITORING
ON THE STILLWATER – ELLERSHOUSE SECTION
OF THE HIGHWAY 101 TWINNING PROJECT,
JULY – OCTOBER, 2002**

**Centre for Water Resources Studies
Faculty of Engineering
Dalhousie University, Halifax, Nova Scotia**

Nova Scotia Department of Transportation and Public Works

CWRS Internal Report 03-07

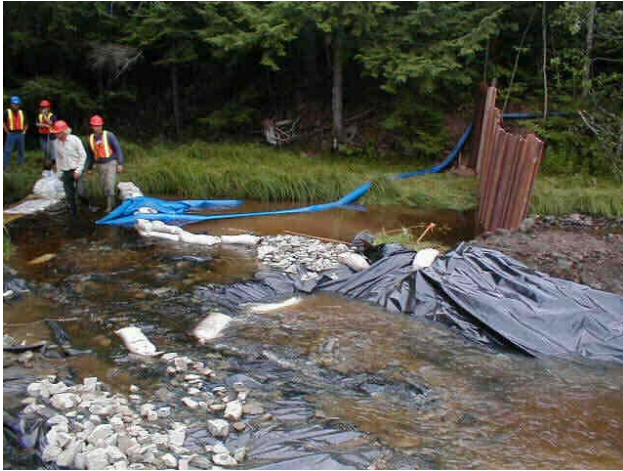
The area encompassing the diversion and culvert extension excavation was flooded during the September 11, 2002 rain event (refer to Figures 2 and 3). The alignment (perpendicular to the flow) and width of the sheet-piling barrier, installed at the upper end of the stream channel to divert flow into the diversion channel, played important roles in the failure of the diversion structure. The diversion channel wall nearest the sheet pile barrier was eroded during the event, permitting access of

flow to the dry area under construction. The sheet-piling was installed perpendicular to the direction of flow, with one wall of the diversion channel extending upstream of the piling barrier. This extension of the diversion channel wall was exposed to turbulent flow caused by the presence of the sheet-pile barrier during periods of high water, as was the case during the September 11-12 event (refer to Figure 4).

Figure 2. Installation of diversion trench for box culvert @ 13+700. Upper end. The sheet-piling was installed perpendicular to the direction of flow. As well, the channel wall extended upstream of the piling barrier. Doing so exposed the exterior side of the wall to water turbulence generated when the sandbag cofferdam was breached during the higher flows experienced during the September 11-12 event.

It is recommended that the design and sequencing of steps for the installation of diversion channels be reviewed. Specifically:

- 8) **Diversion Channels** - It is recommended that the design and sequencing of steps for the installation of diversion channels be reviewed. Three points in particular:

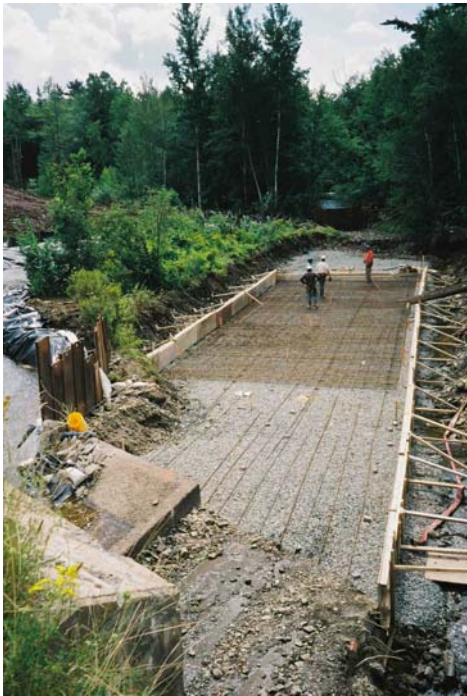
Figure 3a. Area of box culvert installation before and ...

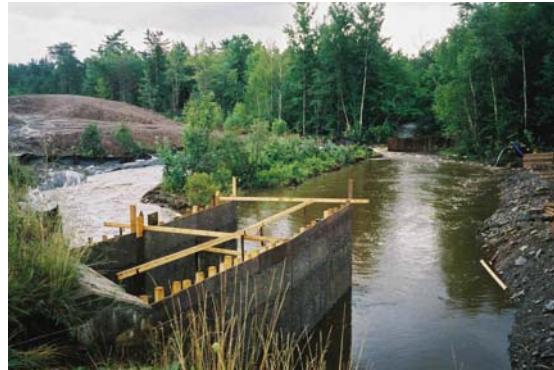
Figure 3b. ... during the September 11-12 rain event.

The September 11-12, 2002 event was characterized by rainfall amounts of 107.4mm in just over 25 hours. As previously mentioned, the diversion channel installed at 13+700 as part of the box culvert extension failed, resulting in the flooding of the working area and displacement of sections of the diversion channel liner. During this event TSS levels reached 3180 mg/L at Bog Brook Station 1. It is likely that eroded soil from this area was a significant contributor to the elevated TSS concentrations recorded downstream.

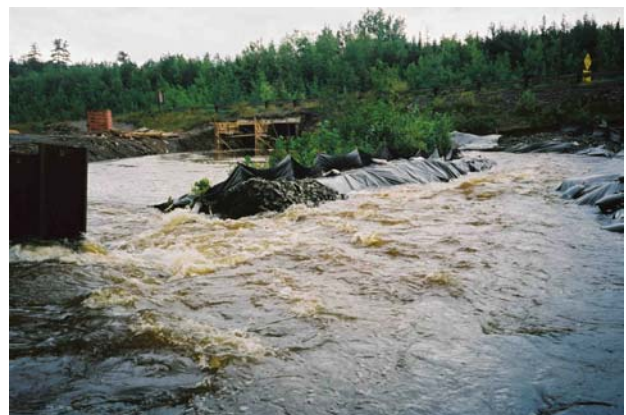
Figure 4. Washout of diversion trench sidewall during September 11-12 rain event. View is looking downstream.

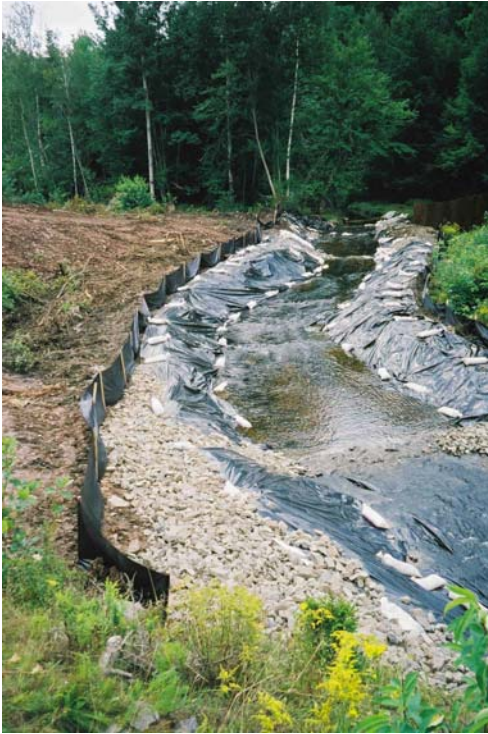
Figure 5a. Diversion channel days before the September 11-12 rain event.

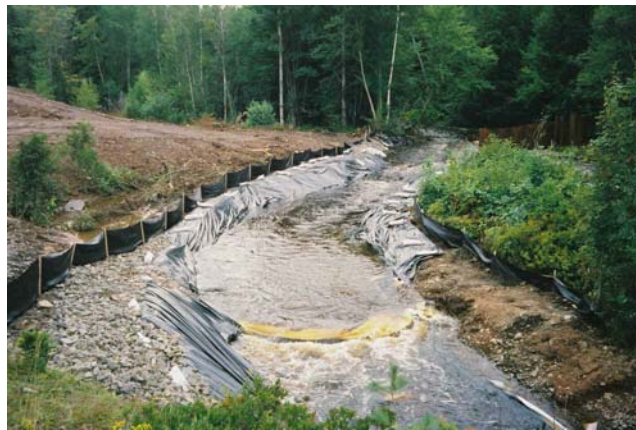
Receding water levels revealed that sections of the plastic liner had been dislodged and the underlying material eroded (see Figures 5a and 5b). The exact cause of the displacement is unknown. It is recommended that the design of these structures be reviewed.

Figure 5b. The same section of the channel days after the same event. Note the displacement of the channel liner along a section of the east bank and stream channel at lower riffle.

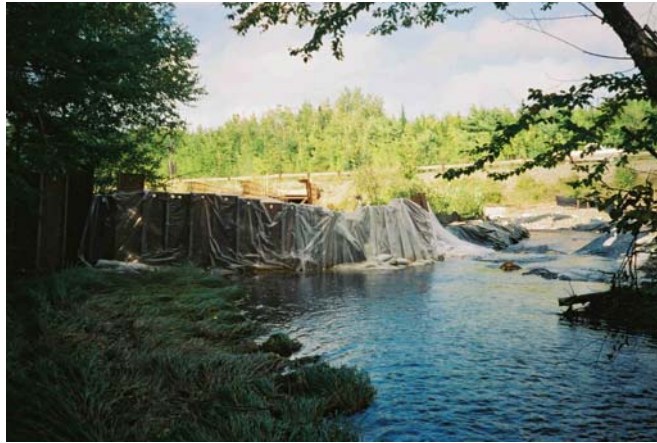
The technique applied to the Bog Brook diversion was that presented in Appendix B of the EPP with the following assumptions. The procedure recommends that flow be maintained in the existing stream channel throughout the operation. However, after allowing flow through the diversion the existing stream channel becomes dammed, and the EPP does not describe the way in which the liner of the diversion channel should be extended through to the existing stream channel. The sheet-piling barrier at the upstream end of the diversion channel was extended by approximately 10 panels, and a plastic barrier was also added to the barrier to reduce seepage (refer to Figures 6a and 6b).

Figure 6a. The sheet-piling barrier at the upstream end of the diversion channel was extended by approximately 10 panels. A plastic barrier was also added to the barrier to reduce seepage.

| September 17 | Sheet pile extended @ box culvert Repaired some coffer dams |

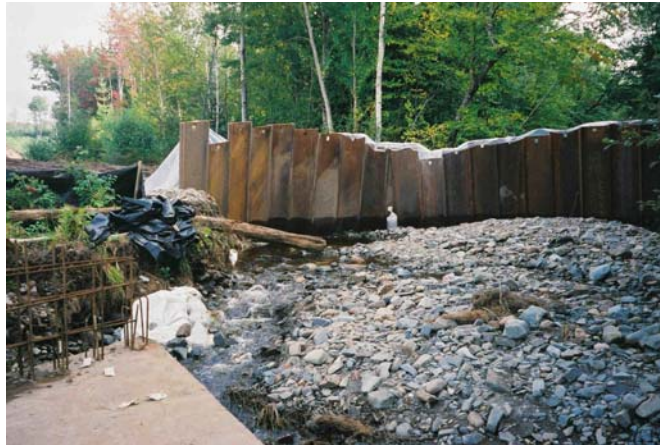
Figure 6b. Backside of the sheet pile structure following the addition of additional panels. The sand bag in center of photo indicates where the original section ended and the extended section began.

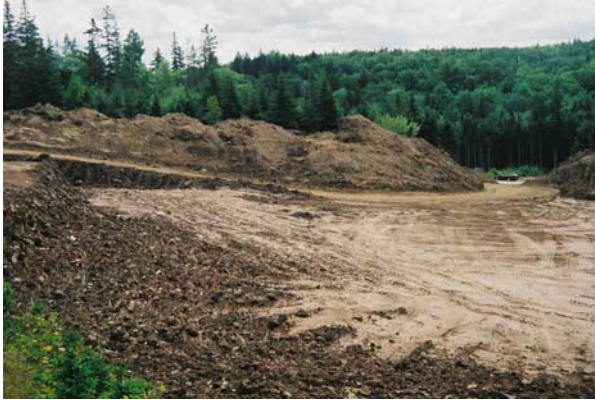
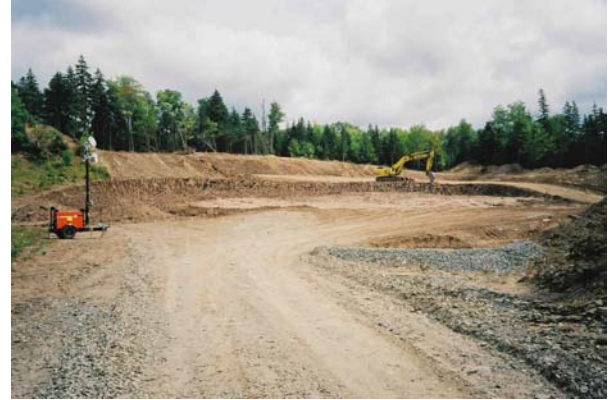
The Spence borrow pit was a major source of total suspended solids observed in Dawson and Bog Brooks (refer to Figure 7a and 7b). Seventeen grab water samples were collected between July 24 and November 12, 2002 from the highway ditch draining the borrow pit. total suspended solids concentrations ranged from <1.8 to 5200 mg/L, with an approximate mean value of 500 mg/L. Development of this pit did not include any preventative ESC measures. Attempts to control runoff leaving the pit while it was operational appeared to be relatively unsuccessful. Flow checks were placed in the highway ditch that drained to Dawson Brook. However, there were no diversion ditches

installed above the pit to “keep clean water clean”. With the exception of a single flow check (Figure 7b), there were also no measures installed to restrict the flow of water out of the pit area, a significant omission in that the entire working area of the pit sloped toward the highway and Dawson Brook.

Figures 7a and 7b. North (looking toward entrance) and south (at entrance looking into pit) entrances to Spence Borrow Pit.

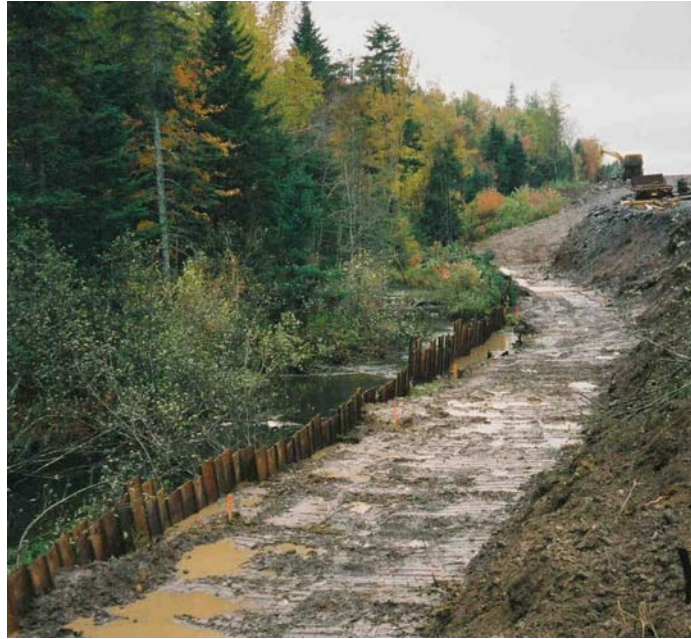
There were no additional forms of ESC employed at the site during the installation and construction of the retaining wall at 16+840 using sheet-piling to separate the main channel of Dawson Brook from the area in which the wall was to be erected (refer to Figure 8).

Figure 8. Retaining wall @ 16+840 showing sheet-piling barrier between construction area and Dawson Brook.

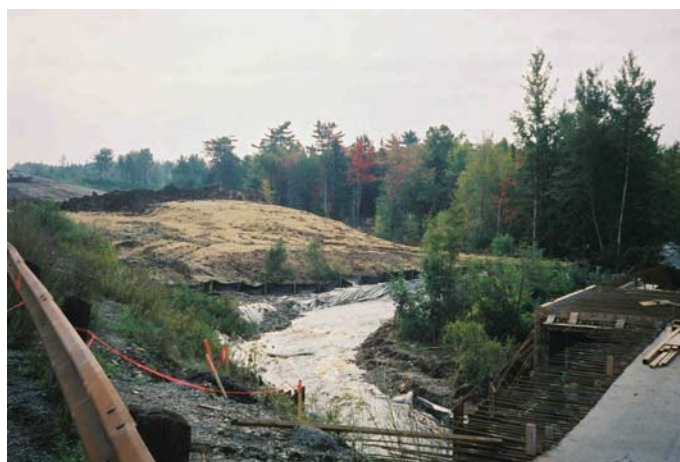
During the construction phase of the box culvert (@13+700) when the diversion channel was operational, a berm was built across the width of the new section of highway to intercept runoff up-gradient of the diversion channel. Straw was used to stabilize the slope between the berm and the silt fence protecting the diversion channel (Figure 9). The berm was installed shortly after a 100+mm rainfall event of September 11-12, 2002. Prior to slope reconstruction and stabilization, there was evidence of rill erosion. A follow-up site inspection was not carried out, therefore, it is not possible to comment on the effectiveness of the treatments on the reduction of soil erosion at this particular location.

Figure 9. Construction zone in the area of the box culvert and stream diversion channel. A temporary berm was constructed to contain and divert runoff from the new section of highway away from the channel. The area down-gradient of the berm was stabilized with straw.

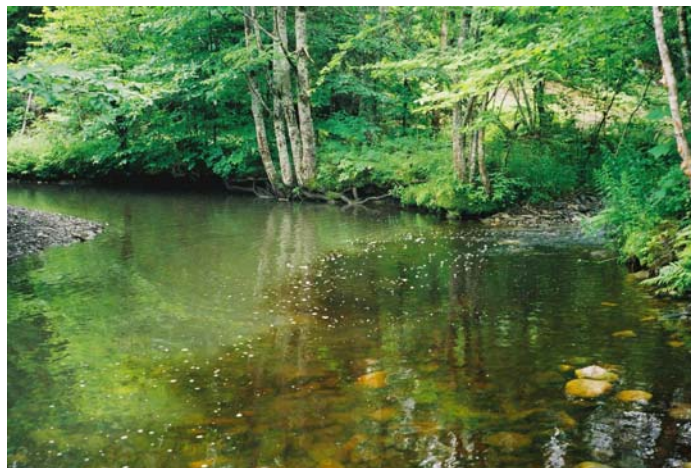
It should be noted that Dawson Brook is tributary to Bog Brook, and because of this some portion of TSS measured in the Dawson Brook watershed will contribute to that observed at selected Bog Brook locations. Refer to Figure 10, Dawson Brook (cloudy body of water to left of picture) entering Bog Brook (smaller channel entering from right side).

Figure 10. The confluence of Dawson Brook (cloudy body of water to left of picture) and Bog Brook (smaller channel entering from right side).

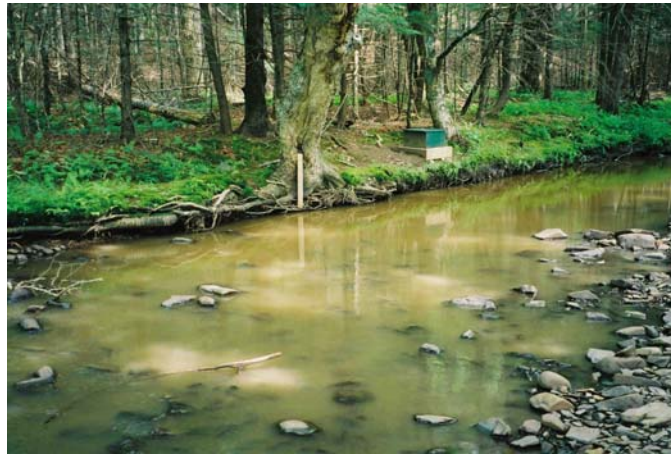
Bog Brook flows were recorded between July 12 and October 28, 2002. Figure 11 illustrates the stage recording site where a metal box mounted to a concrete pad was used to house the data logger and pressure transducer, and a staff gauge fastened to the tree was used to measure stage for pressure transducer calibration.

Figure 11. Bog Brook stage recording site. A metal box mounted to a concrete pad was used to house the data logger and pressure transducer. A staff gauge fastened to the tree was used to measure stage for pressure transducer calibration.

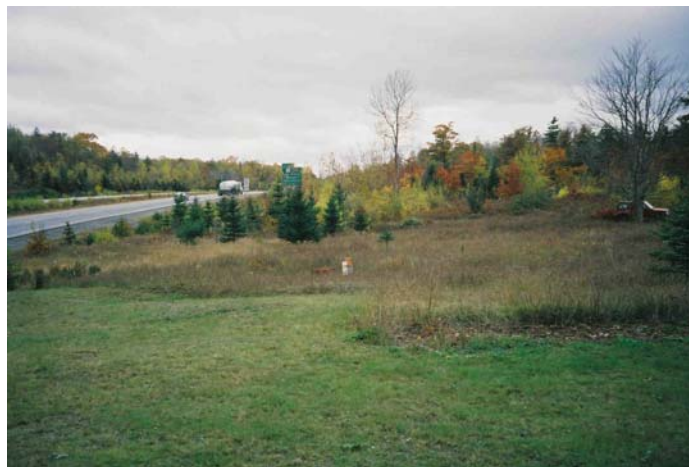
Figure 12. Tipping bucket and standard rain gauge were located on the property of Nathaniel Spence bordering Highway 101 on the northeast side of the Ellershouse highway overpass.

A tipping-bucket rainfall gauge was connected to a CR10 datalogger and was programmed to record bucket tips occurring at 1-minute intervals (each tip is equivalent to 0.2mm of rainfall). The instrument was installed on July 16, 2002, and a standard rain gauge was installed at the site on July 19 for data cross-referencing purposes. For this project, an event is defined as one with a minimum of 0.2mm total rainfall falling over a 24 hour period and discrete events separated by a period of at least 24 hours with no measurable (<0.2mm) rainfall. The number of rain events occurring during the study period of July 19 to October 28, 2002 was 43 (34 events between 0.2-10mm, 7 between 10-25mm, and 6 greater than 25mm).

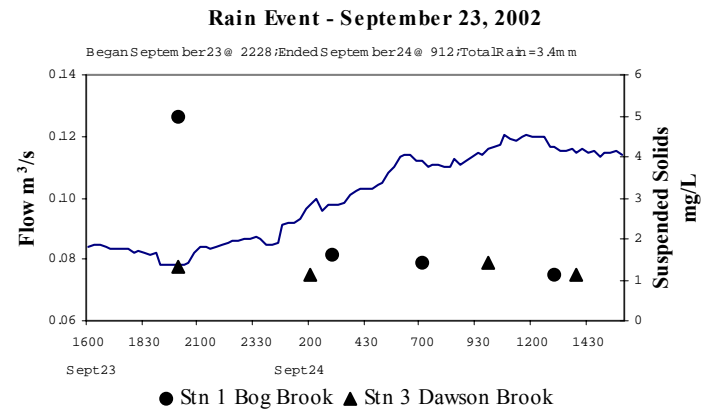
Table IV.1 Rain event summary plots.

Time Series Plots of Total Suspended Solids Versus Flow
